KNAPP BROOK SITE NO. 1
VT. 00076

PHASE I INSPECTION REPORT
NATIONAL DAM INSPECTION PROGRAM

DEPARTMENT OF THE ARMY
NEW ENGLAND DIVISION, CORPS OF ENGINEERS
WALTHAM, MASS. 02154
MARCH 1980

Identification No: VT00076
Name of Dam: Knapp Brook Site No. 1
Town: Cavendish
County and State: Windsor County, Vermont
Stream: Knapp Brook
Date of Inspection: April 23, 1979 and May 22, 1979

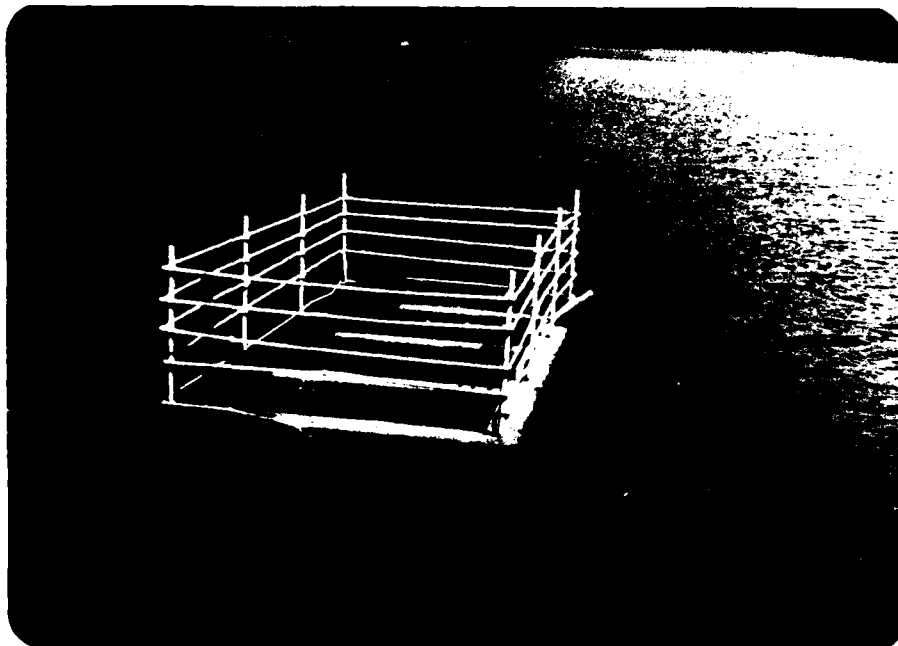
The primary discharge structure is the 12-foot by 6.5 foot drop structure (see Photo 5). This structure functions as a weir for the first 2 feet of head. For higher heads it is controlled by orifice flow by the 4-foot concrete discharge pipe. At the present time the north side of the structure is equipped with stop logs which run to full height of the concrete structure. The relative location of this structure, 15 feet from the dam, and its primary use as a spillway could cause debris to collect around the iron pipe railing. This could lead to possible reduction in discharge.

The 12-foot by 6.5-foot concrete drop structure is equipped with stop logs from the invert of the 48-inch concrete pipe to the top of the drop structure spillway. The stop logs appear to be in good condition. The inspection team was unable to gain access to the structure during the two inspection trips. Presently the stop logs are installed all the way to the top of the drop structure and according to Fish and Game personnel, this is the standard operating procedure for the entire year.

#5. DROP STRUCTURE WITH STOP LOGS IN AND RAILING.
